FOR <i>K. Faw</i> <i>(for R.P.B.)</i> R. P. Bass	SUBJECT CLASSIFICATION <i>Bushings - Capacitors</i>	NO. 50TP170-1
		DATE 7/19/51

The Operation of 5 Kv Glass and Porcelain  
Bushings in Salt-Fog Atmosphere. Report II

INFORMATION PREPARED FOR High Voltage Bushing Division

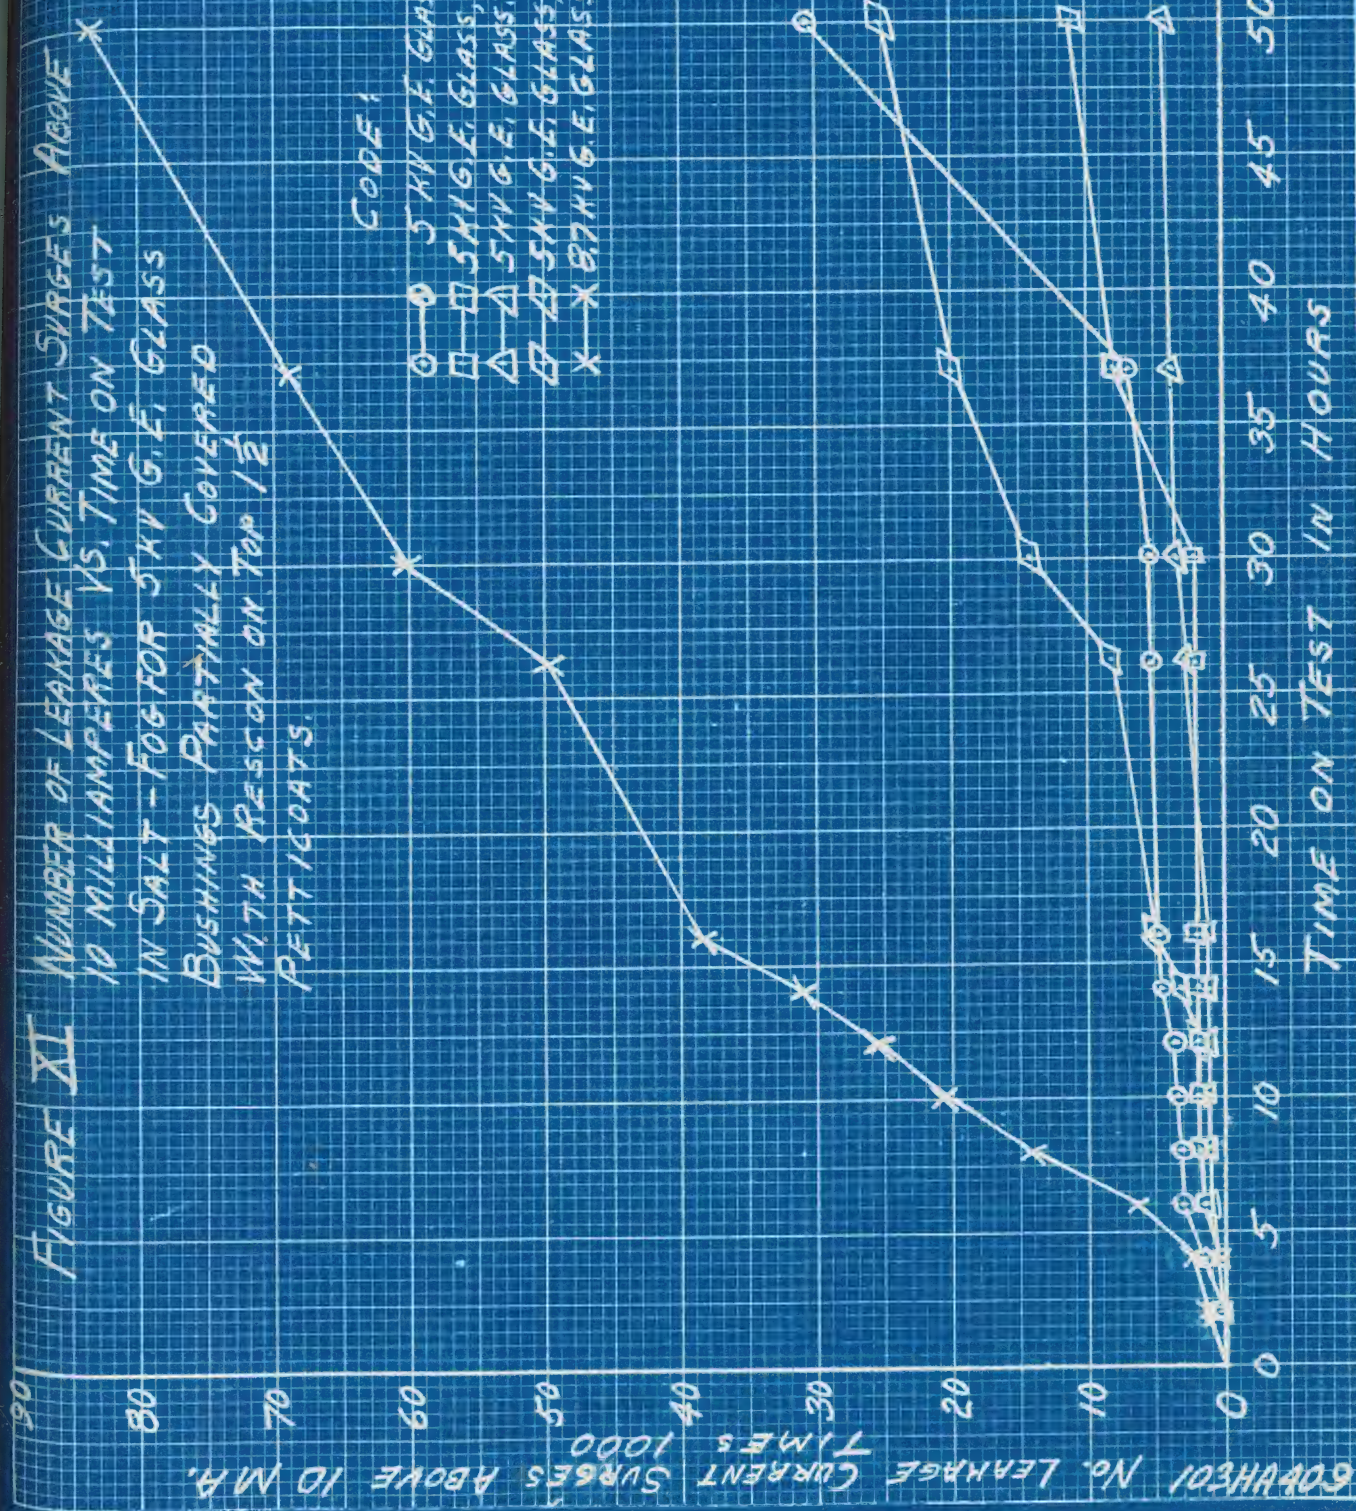
FIGURE XII NUMBER OF LEAKAGE CURRENT SURGES ABOVE 10 MILLIAMPERES VS. TIME ON TEST IN SALT FOG FOR 5 KV G.E. GLASS BUSHINGS PARTIALLY COVERED WITH RESCON ON BOTTOM 1/2 PETTICOATS.

- 5 KV G.E. GLASS, RESISTANCE - 3 MEGOHMS
- 5 KV G.E. GLASS, RESISTANCE - 50 MEGOHMS
- △ 5 KV G.E. GLASS.
- ◇ 5 KV G.E. GLASS, RESISTANCE - 300 MEGOHMS

3. Semi-conducting Rescon surface coatings, partial and complete, have, so far, been unsuccessful in improving the performance of bushings operating in a salt-fog atmosphere. Figures IV, V, VI, XI, XII, and XIII.

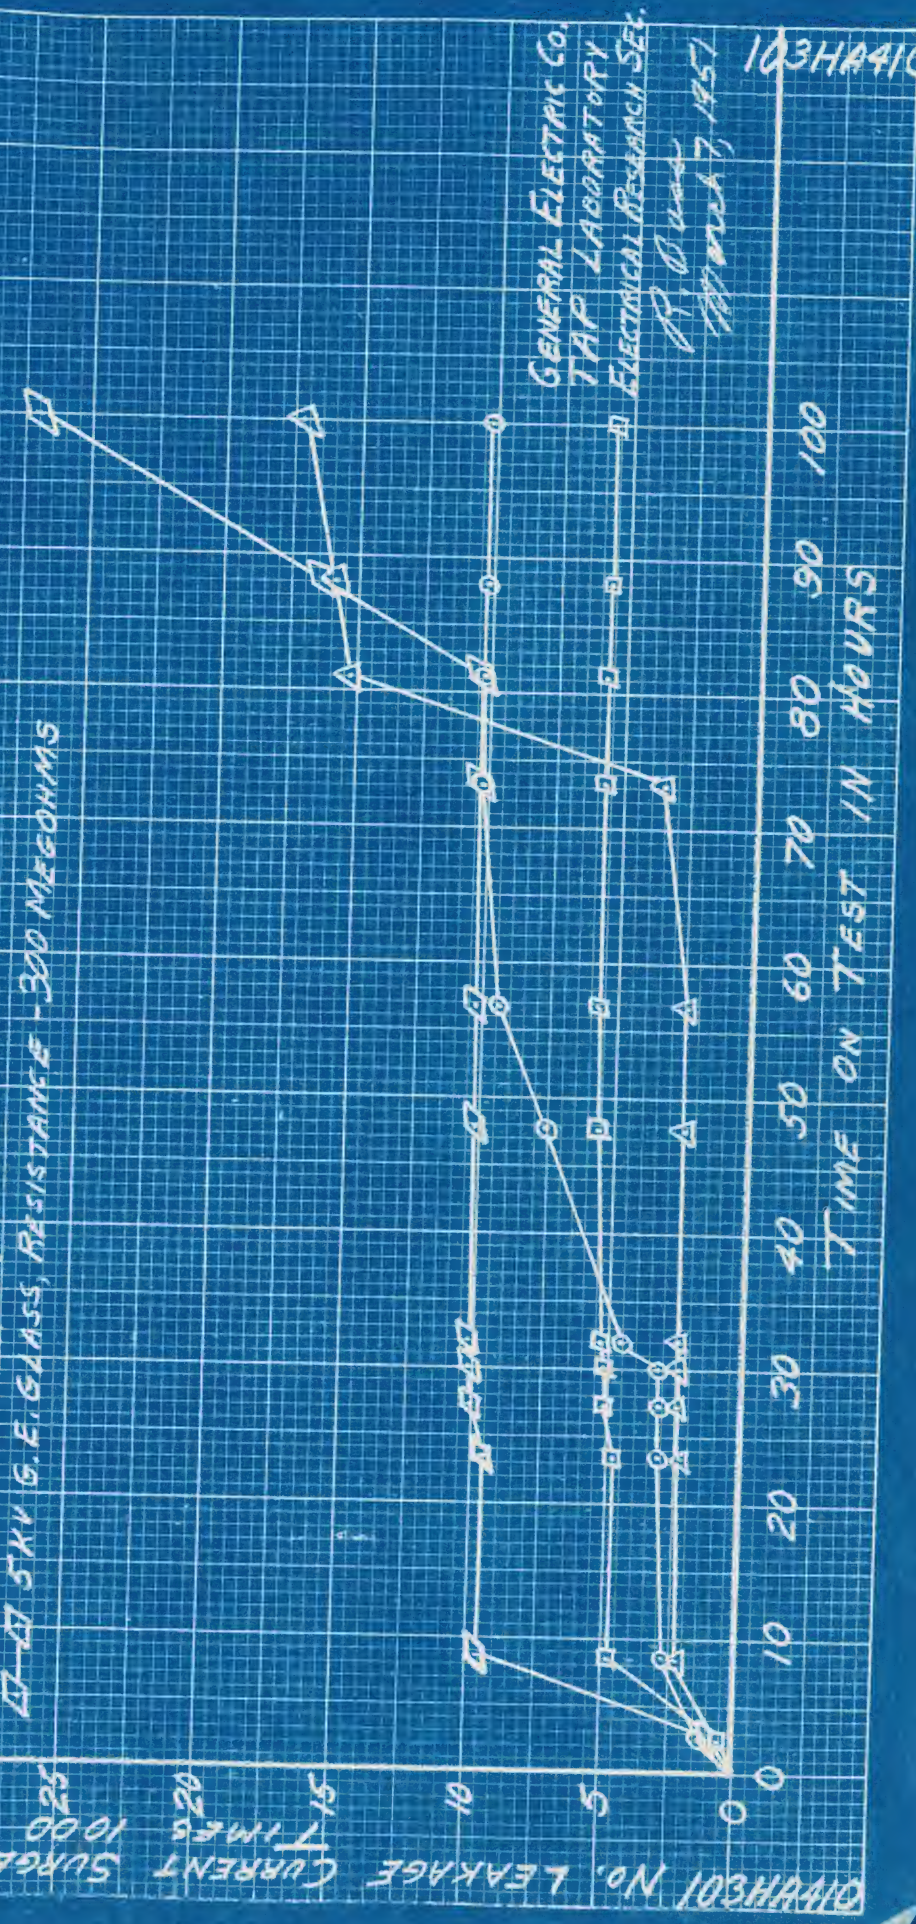
103HA410

FIGURE XIII NUMBER OF LEAKAGE CURRENT SURGES ABOVE

10 MILLIAMPERES VS. TIME ON TEST FOR G. E. GLASS, 5KV BUSHINGS WITH INTERNAL RESCON COATINGS FROM TERMINAL TO GROUND FLANGE.

- RESISTANCE — 2760 MEGOHMS
- RESISTANCE — 2860 MEGOHMS
- X—X RESISTANCE — 9000 MEGOHMS
- △—△ NO COATING
- ◻—◻ RESISTANCE — 42,000 MEGOHMS

Although semi-conducting coatings have been unsuccessful, so far, it is worth noting (Fig. XIII) that the test samples, with internal coatings, had very few current surges in the early stages. This would lead one to believe that there may be some kind of conducting coating that would greatly reduce surface deterioration.

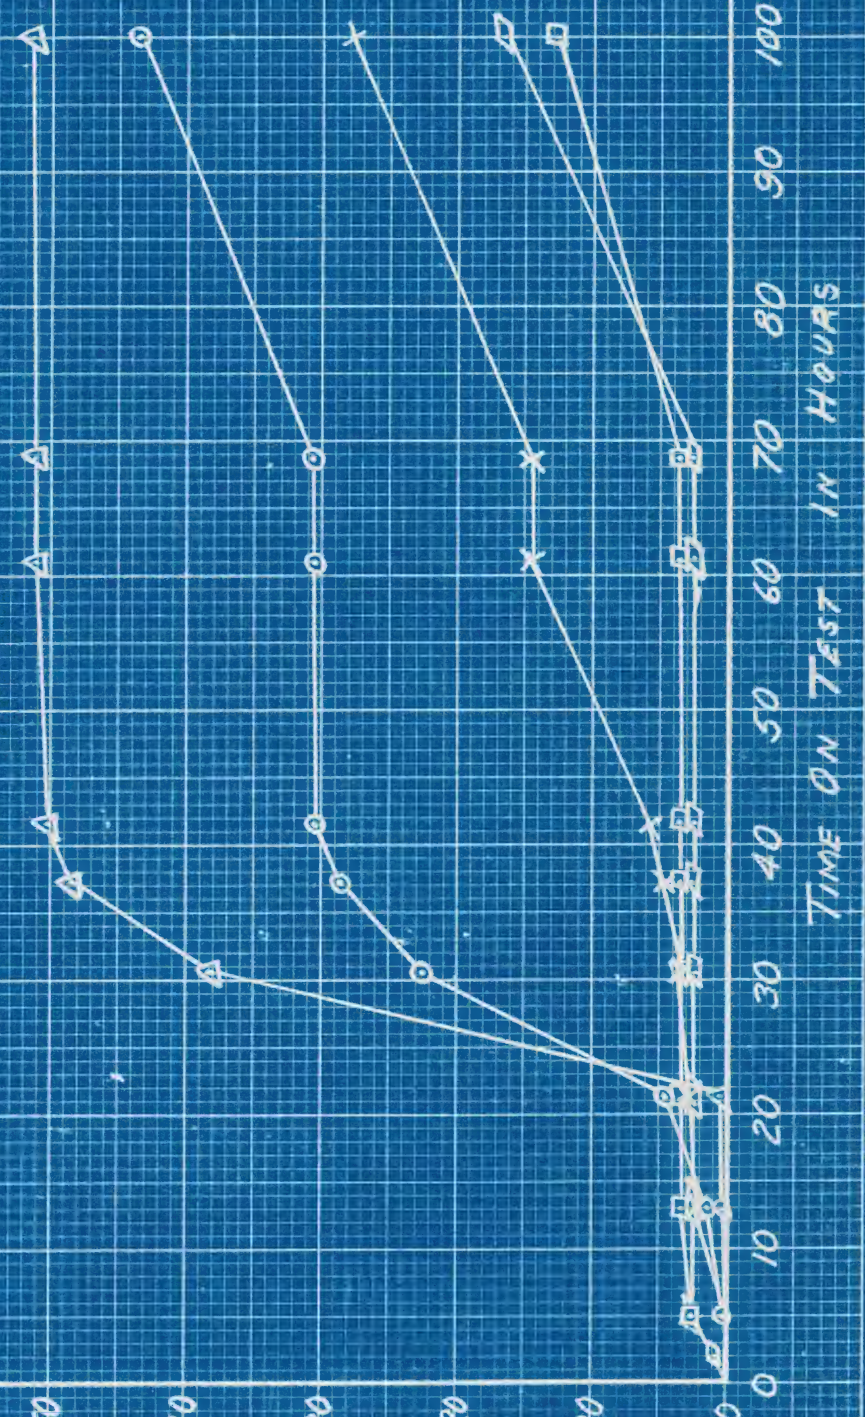
FIGURE XIV NUMBER OF LEAKAGE CURRENT SURGES ABOVE 10 MILLIAMPERES VS. TIME ON TEST IN SALT-FOG FOR TWO 5 KV G.E.

GLASS BUSHINGS.

CODE:  
 ○ 5 KV G.E. GLASS BUSHING  
 □ DIXIEAL SEALING INSULATED CABLE & TERMINAL CONNECTION

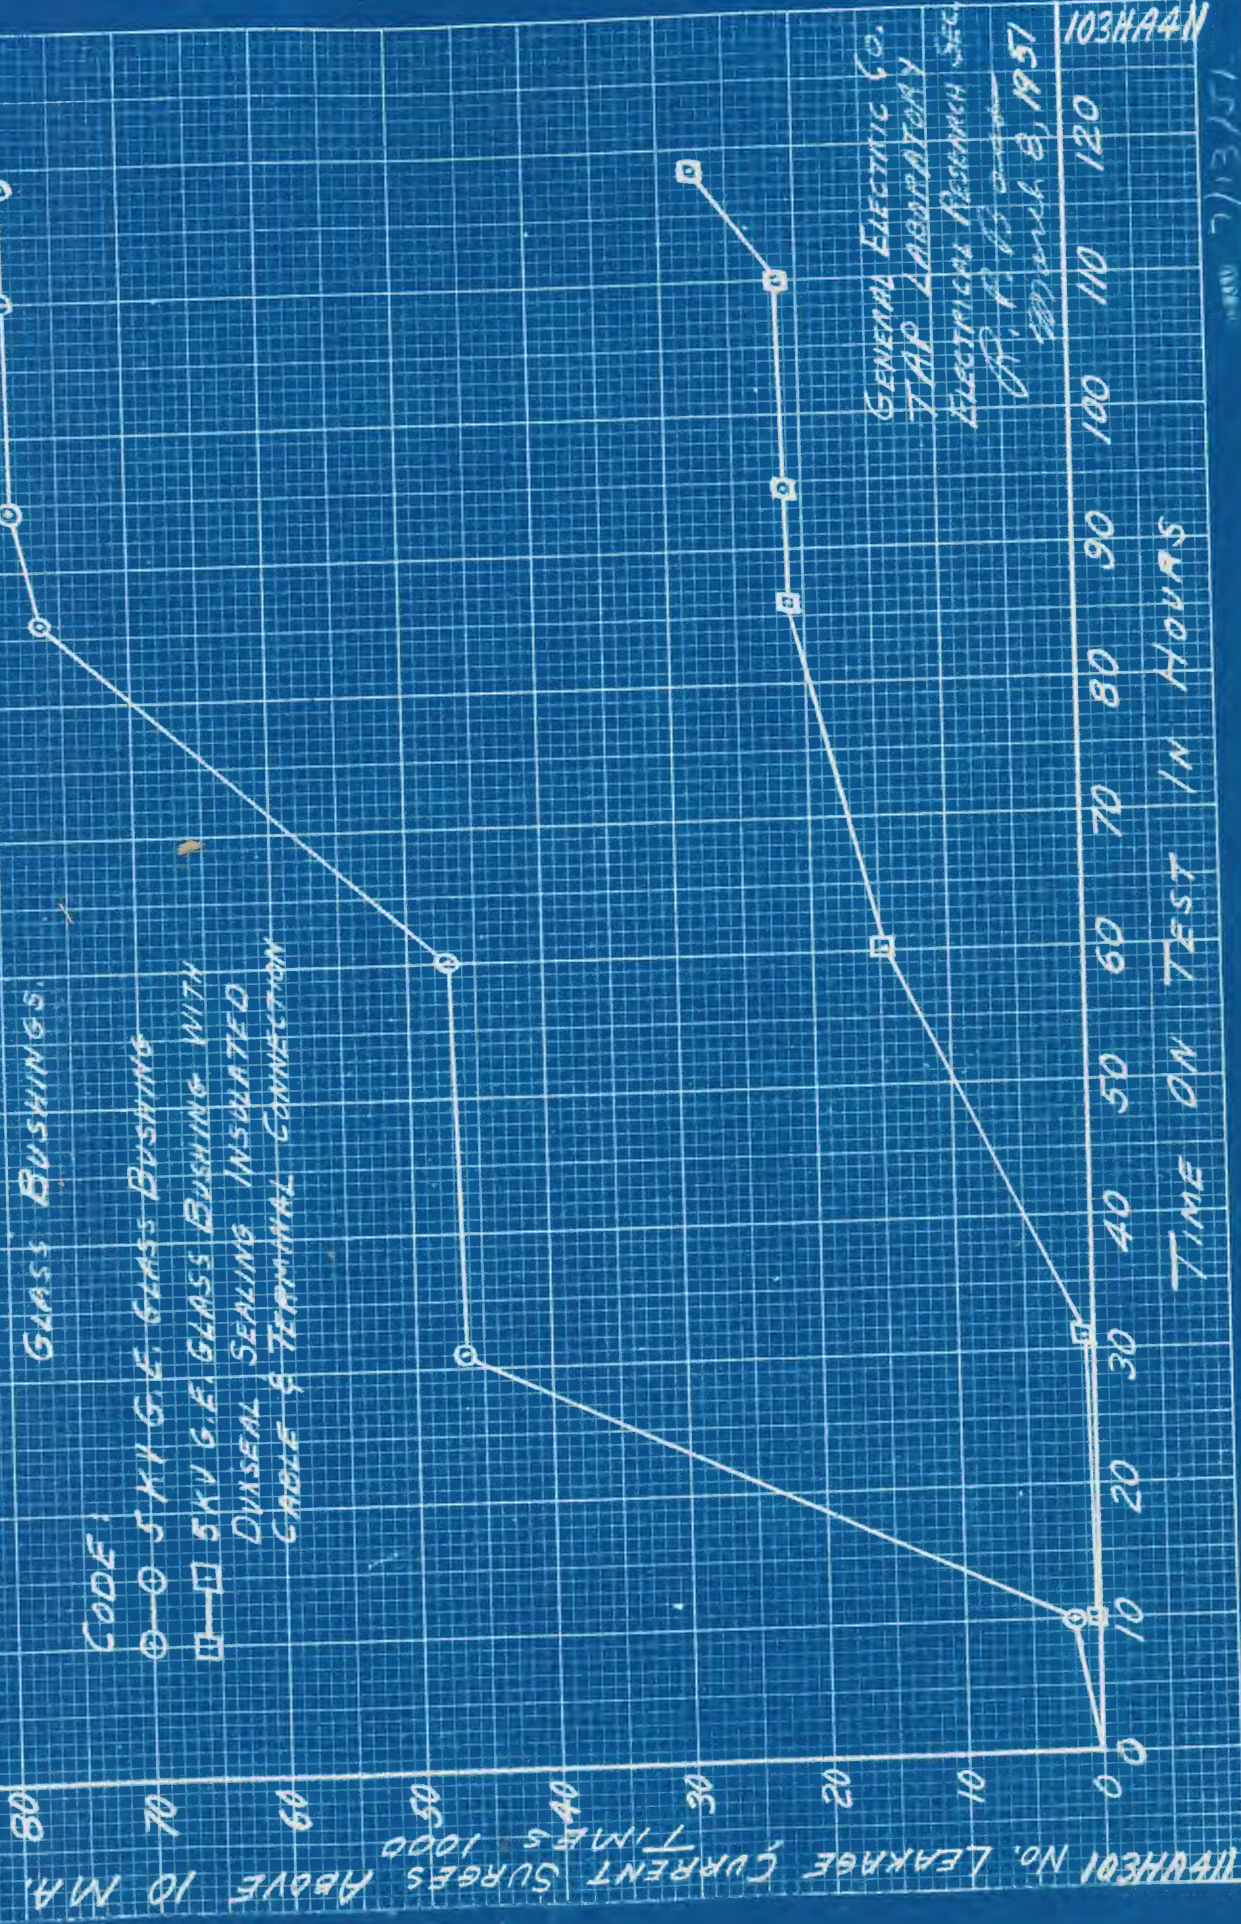
FIGURE XVI LEAKAGE CURRENT SURGES VS. TIME ON TEST FOR G.E. GLASS BUSHINGS

4. Salt deposition and surface deterioration have been greatly reduced on 14B4, 5 kv G.E. amber glass bushings that had the insulated moisture resistant cable and bushing terminal connection sealed against moisture by Kearney "Airseal". Figures VII, IX, XVI, and XVIII.

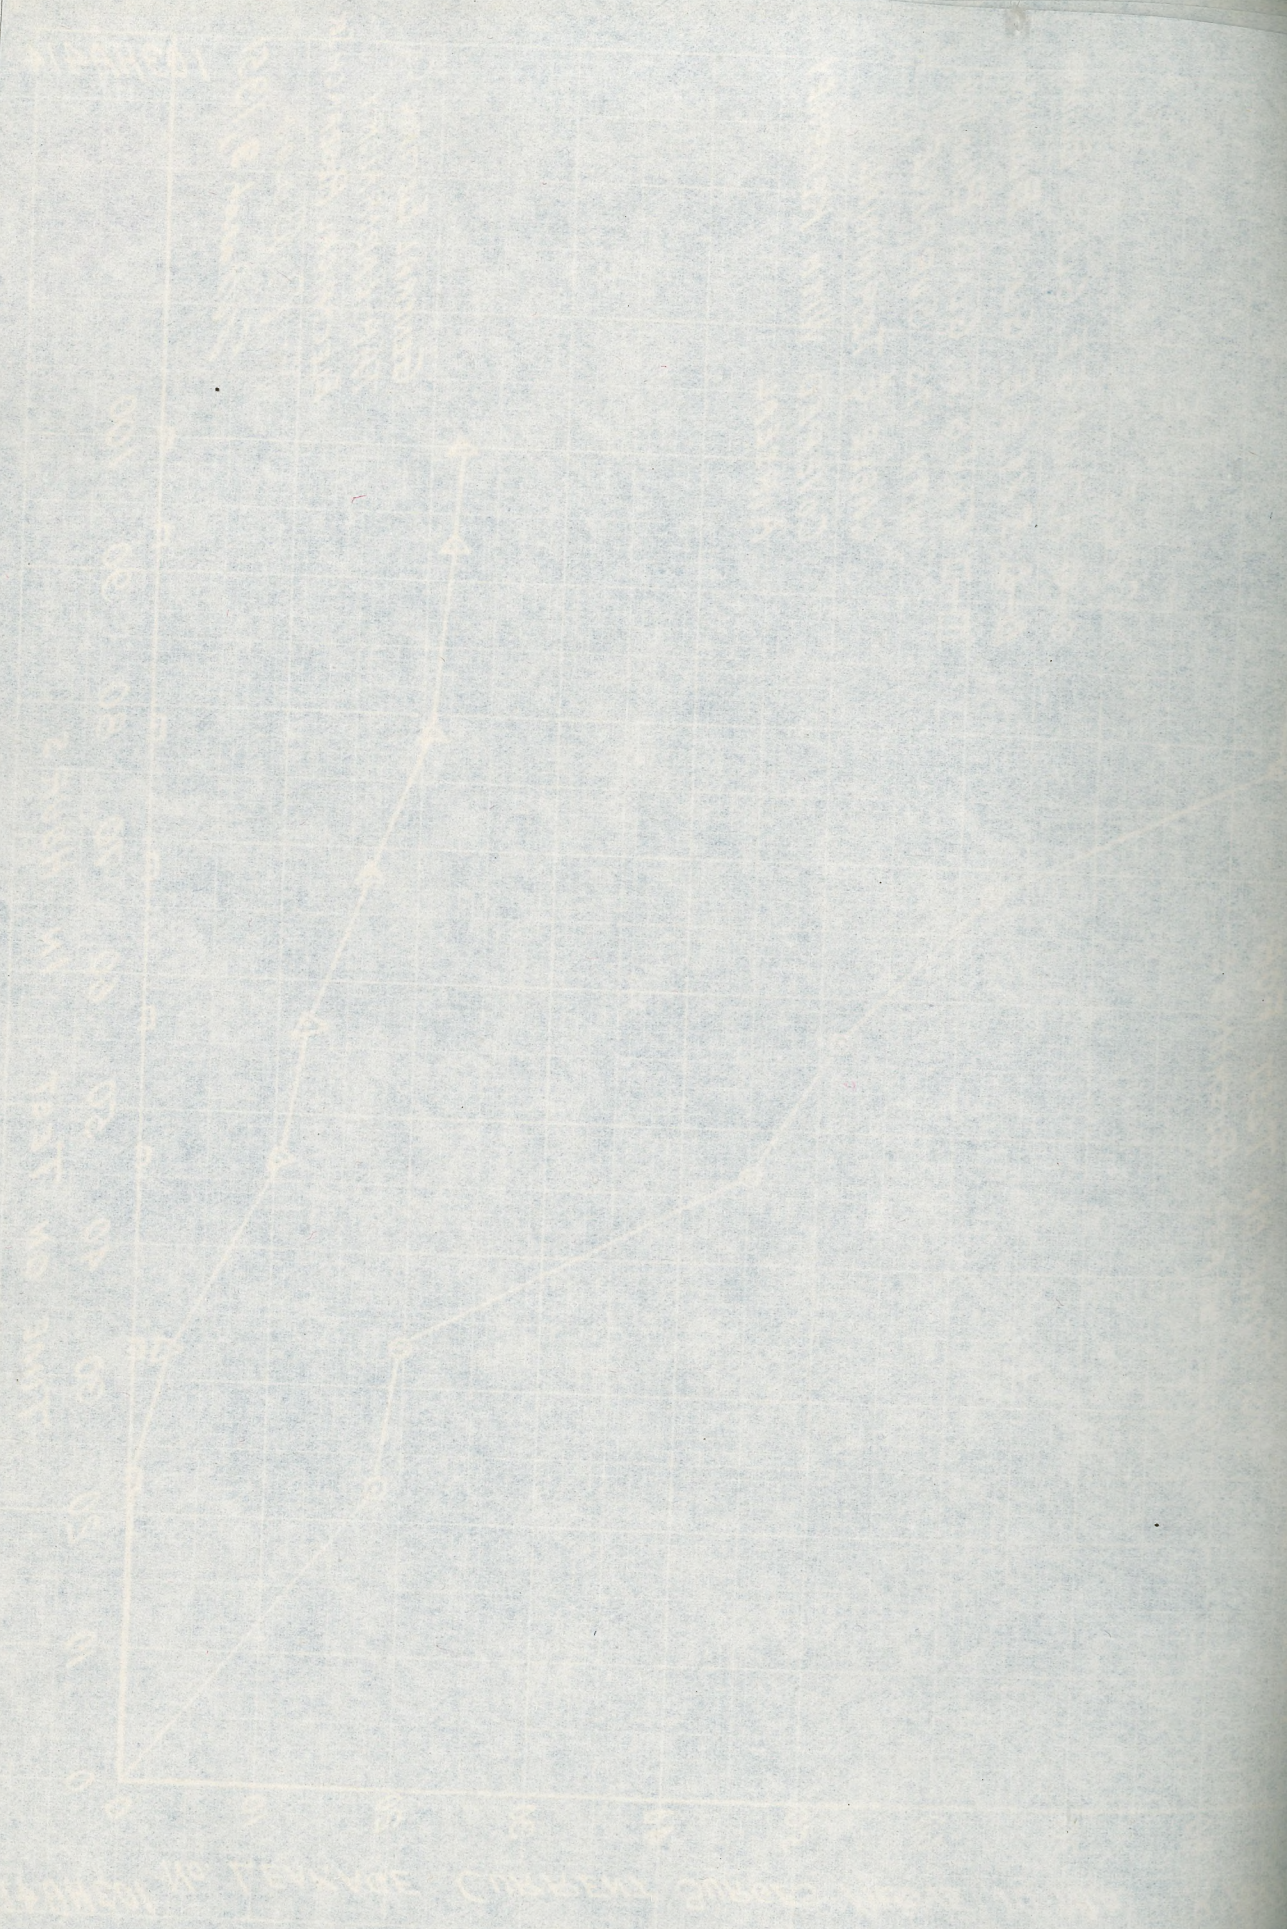
103 HA 744

FIGURE XVII

NUMBER OF LEAKAGE CURRENT SURGES ABOVE 10 MA.  
 V.A. TIME ON TEST IN SALT FOG  
 FOR 5KV GE 1484 GLASS BUSHINGS

- BUSHING #1 } PLAIN BUSHING - NO INSULATION
- BUSHING #2 } INSULATED CABLE AND ONE PAD OF KEARNEY AIRSEAL OVER TERMINALS
- △ BUSHING #3 }

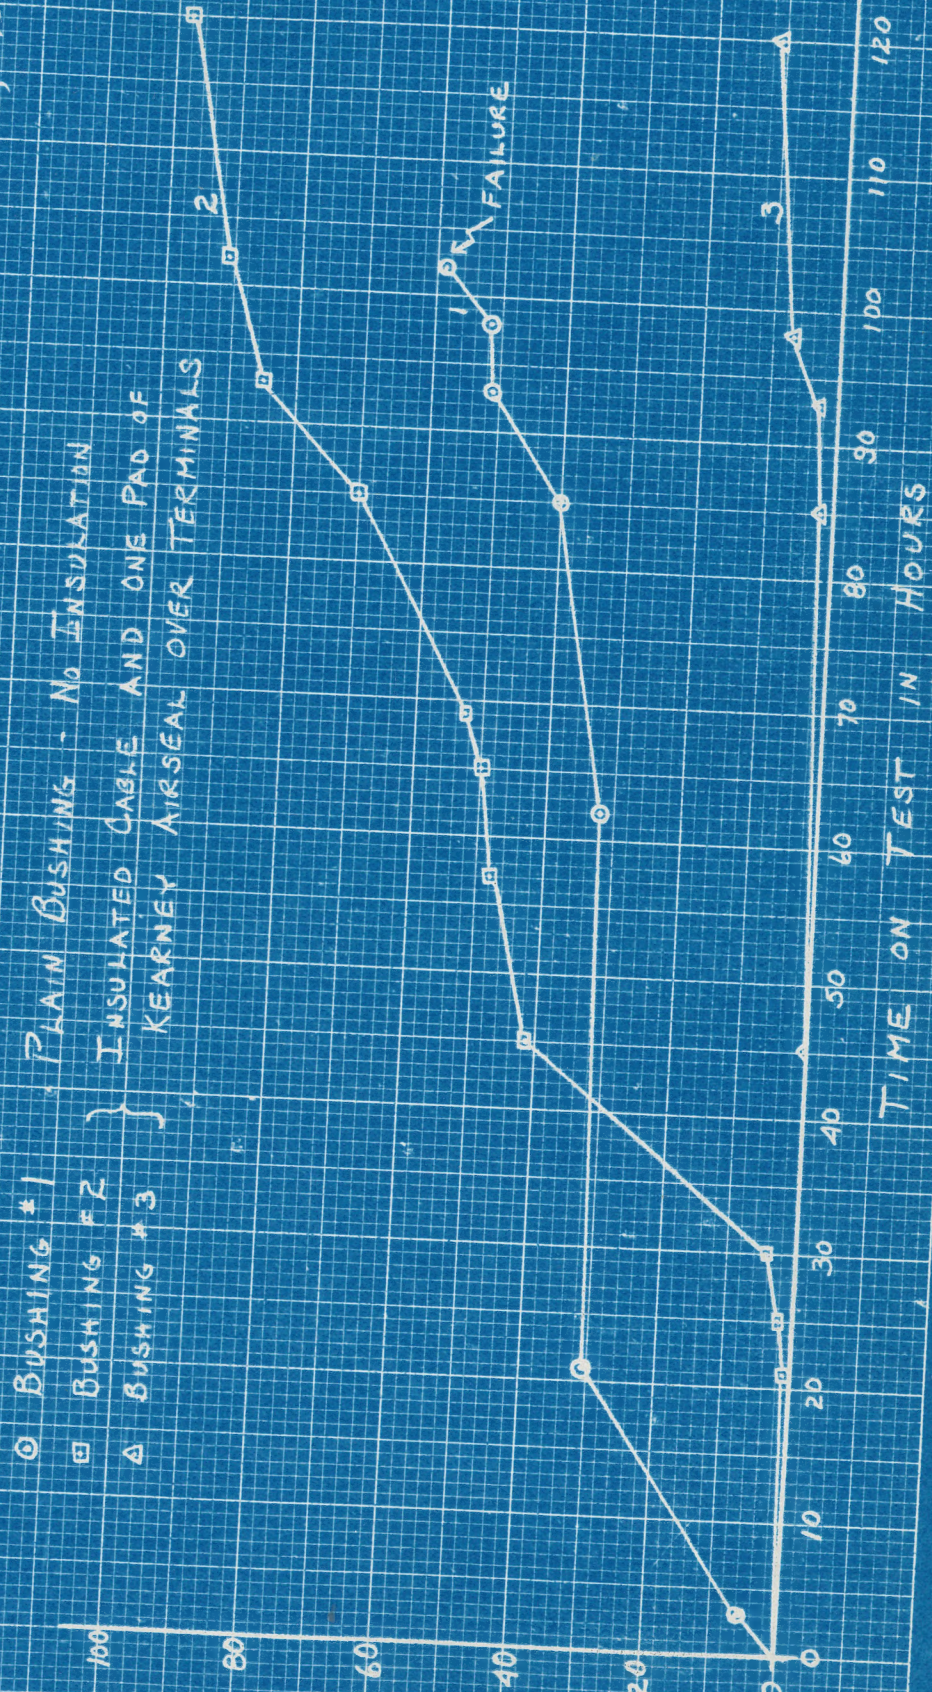
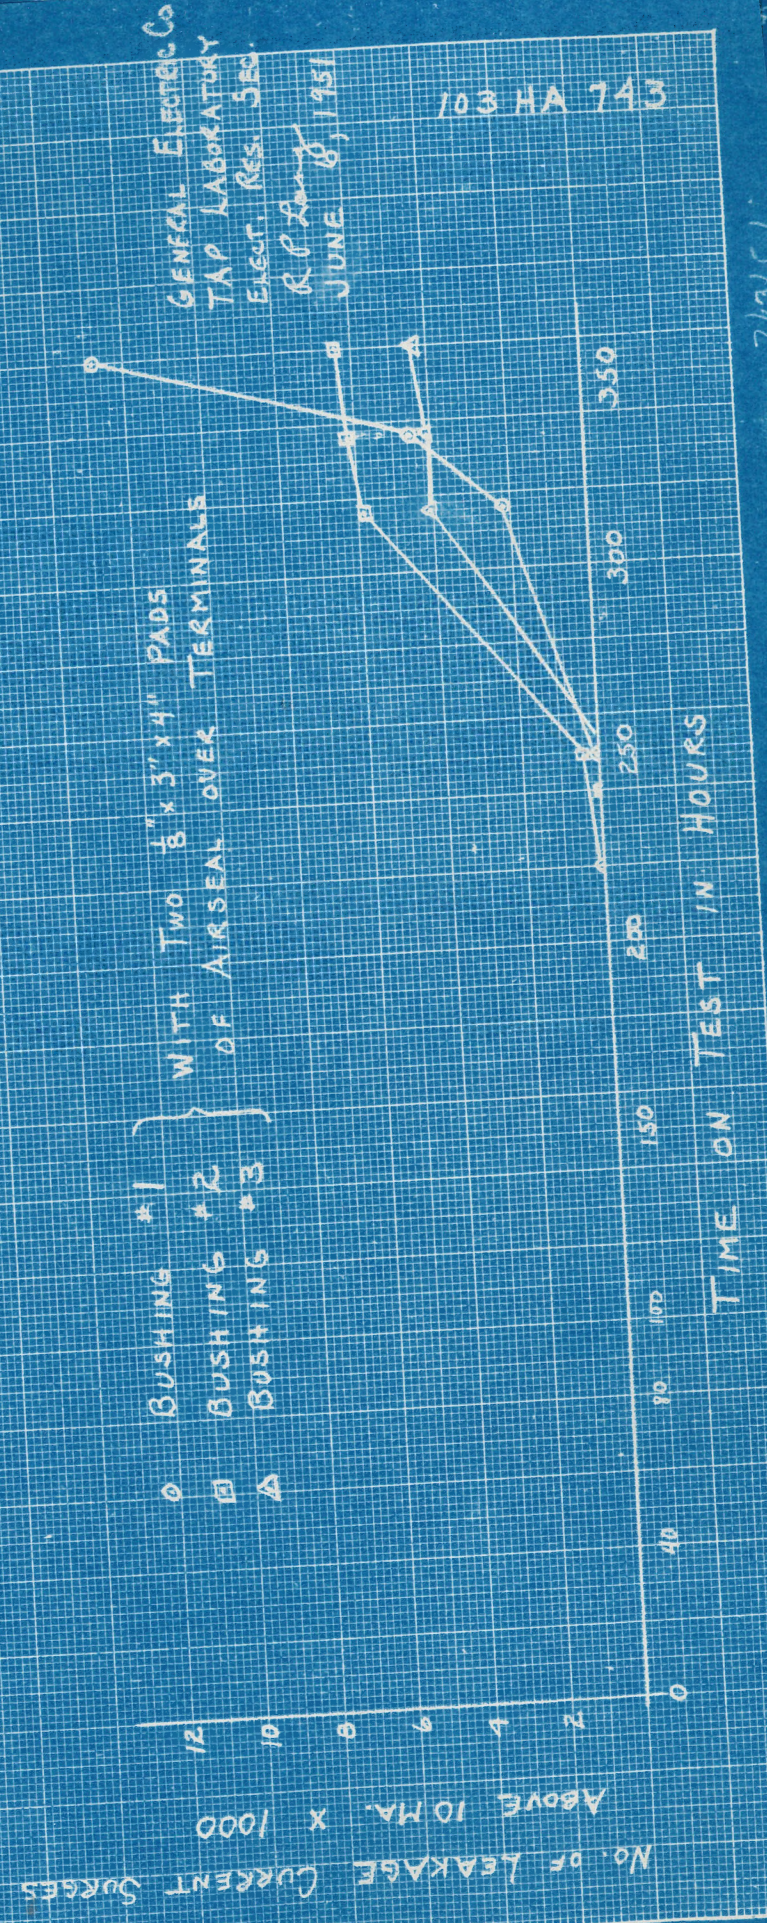
103 HA 743

FIGURE XVIII

NUMBER OF LEAKAGE CURRENT SURGES ABOVE 10MA  
 VS. TIME ON TEST IN SALT FOG  
 FOR 5KV GE GLASS 140H BUSHINGS  
 WITH KEARNEY AIRSEAL OVER TERMINALS  
 AND KOME 2TW CABLE TO VOLTAGE SOURCE

○ BUSHING #1 } WITH TWO 8" x 3" x 4" PADS  
 □ BUSHING #2 } OF AIRSEAL OVER TERMINALS  
 ▲ BUSHING #3 }

The increase in counting rate after 250 hours (Fig. XVIII) indicates that further investigation may be necessary to establish the life expectancy for this material.

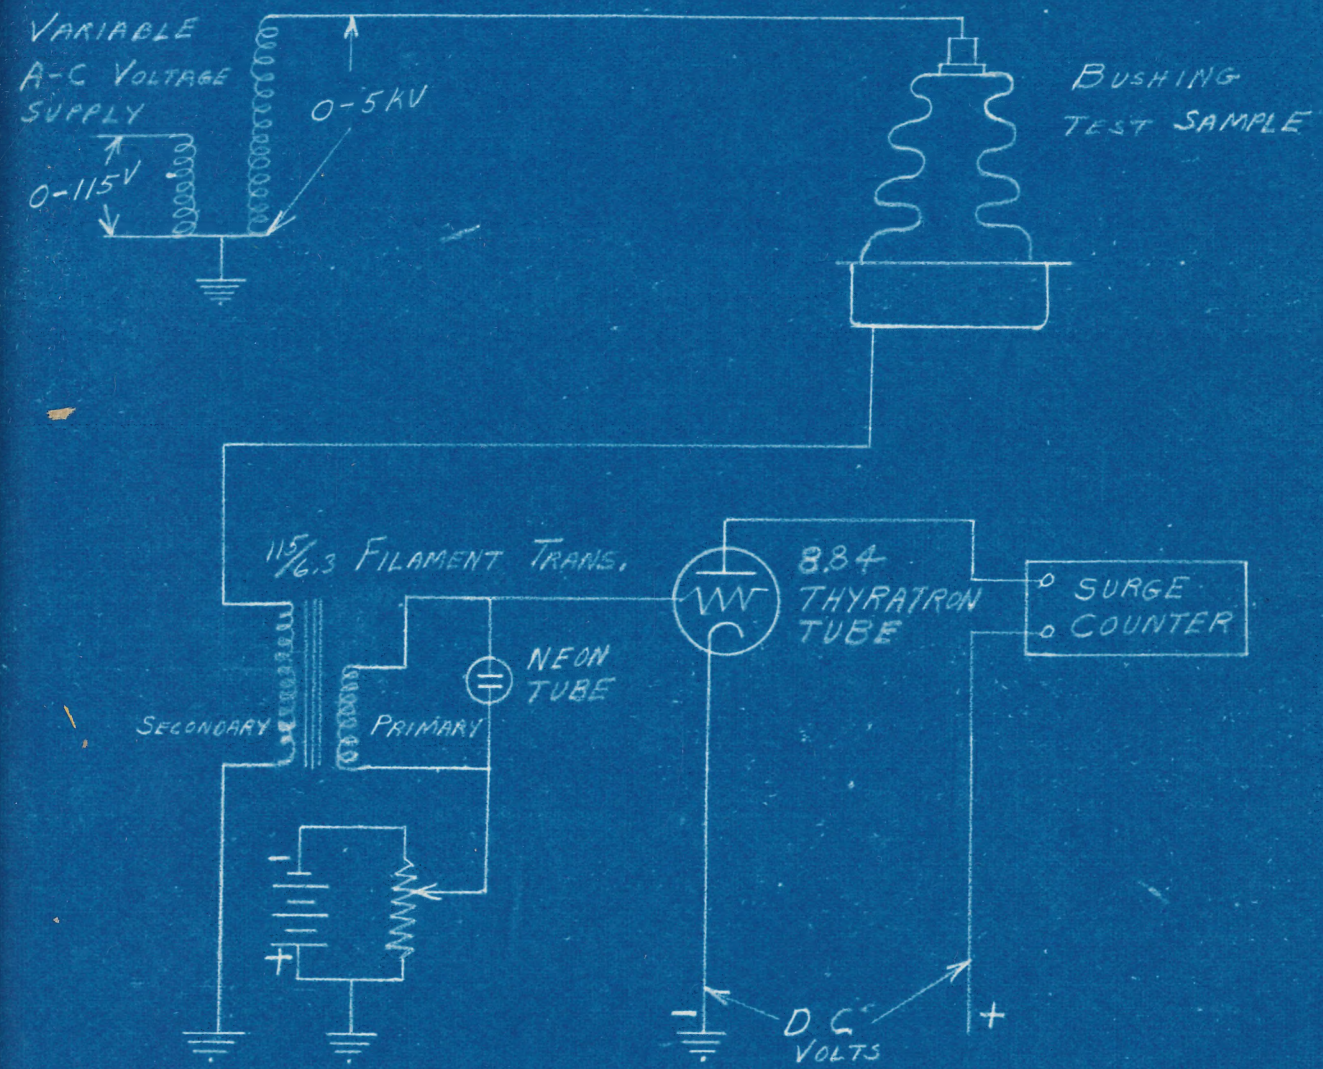
103 HA 406  
 CONT ON SHEET SH. NO. 1

FIGURE XIX SINGLE STAGE SCHEMATIC DIAGRAM OF SIX STAGE LEAKAGE CURRENT SURGE COUNTER FOR USE ON TEST SAMPLES IN SALT-FOG TESTS.

In order to understand better these arc discharges and the effect on the arcing rate of factors such as contour design, six leakage current surge counters were constructed. Each surge counter was constructed according to the schematic diagram shown in Figure XIX. The operation of these surge counters is dependent primarily on the instability of the moisture film on the bushing surface. When one area of the bushing develops a thinner, high resistance film, a predominant amount of voltage appears across this drier area. If the voltage that appears is sufficiently great, an arc short-circuits what was formerly a voltage-carrying surface and the ampere level reached is then limited largely by the resistance of the remaining film. This increased resistance quenches the arc and reduces the leakage current to a lower value.

Briefly, the method of detecting and counting the leakage current surges is as follows: The mounting flange of the test bushing is connected to ground through the secondary winding of a 6.3/115 volt filament transformer. When an arc occurs, the current surge induces a voltage in the primary of the filament transformer which bucks the negative d-c bias on the grid of the 884 Thyatron tube. This triggers the Thyatron tube which then conducts sufficient current to operate the surge counter. The surge counter has a contact arrangement that opens the plate circuit of the Thyatron tube immediately after the counter operates. Opening the plate circuit stops the flow of current and allows the grid to regain control of the tube. The circuit is then ready to count the next current surge.

The surge counters were set to record all current surges above a crest value of 10 ma. This value may be adjusted as desired by changing the negative bias voltage. Figure XX shows a curve of the crest value of leakage current surges vs. the magnitude of the negative bias supply.
